DEPARTMENT OF THE ARMY
US ARMY INSTALLATION MANAGEMENT COMMAND, PACIFIC REGION
HEADQUARTERS, UNITED STATES ARMY GARRISON, HAWAII
SCHOFIELD BARRACKS, HAWAII 96857-5000

Periodic Progress Report dated March 30, 2007

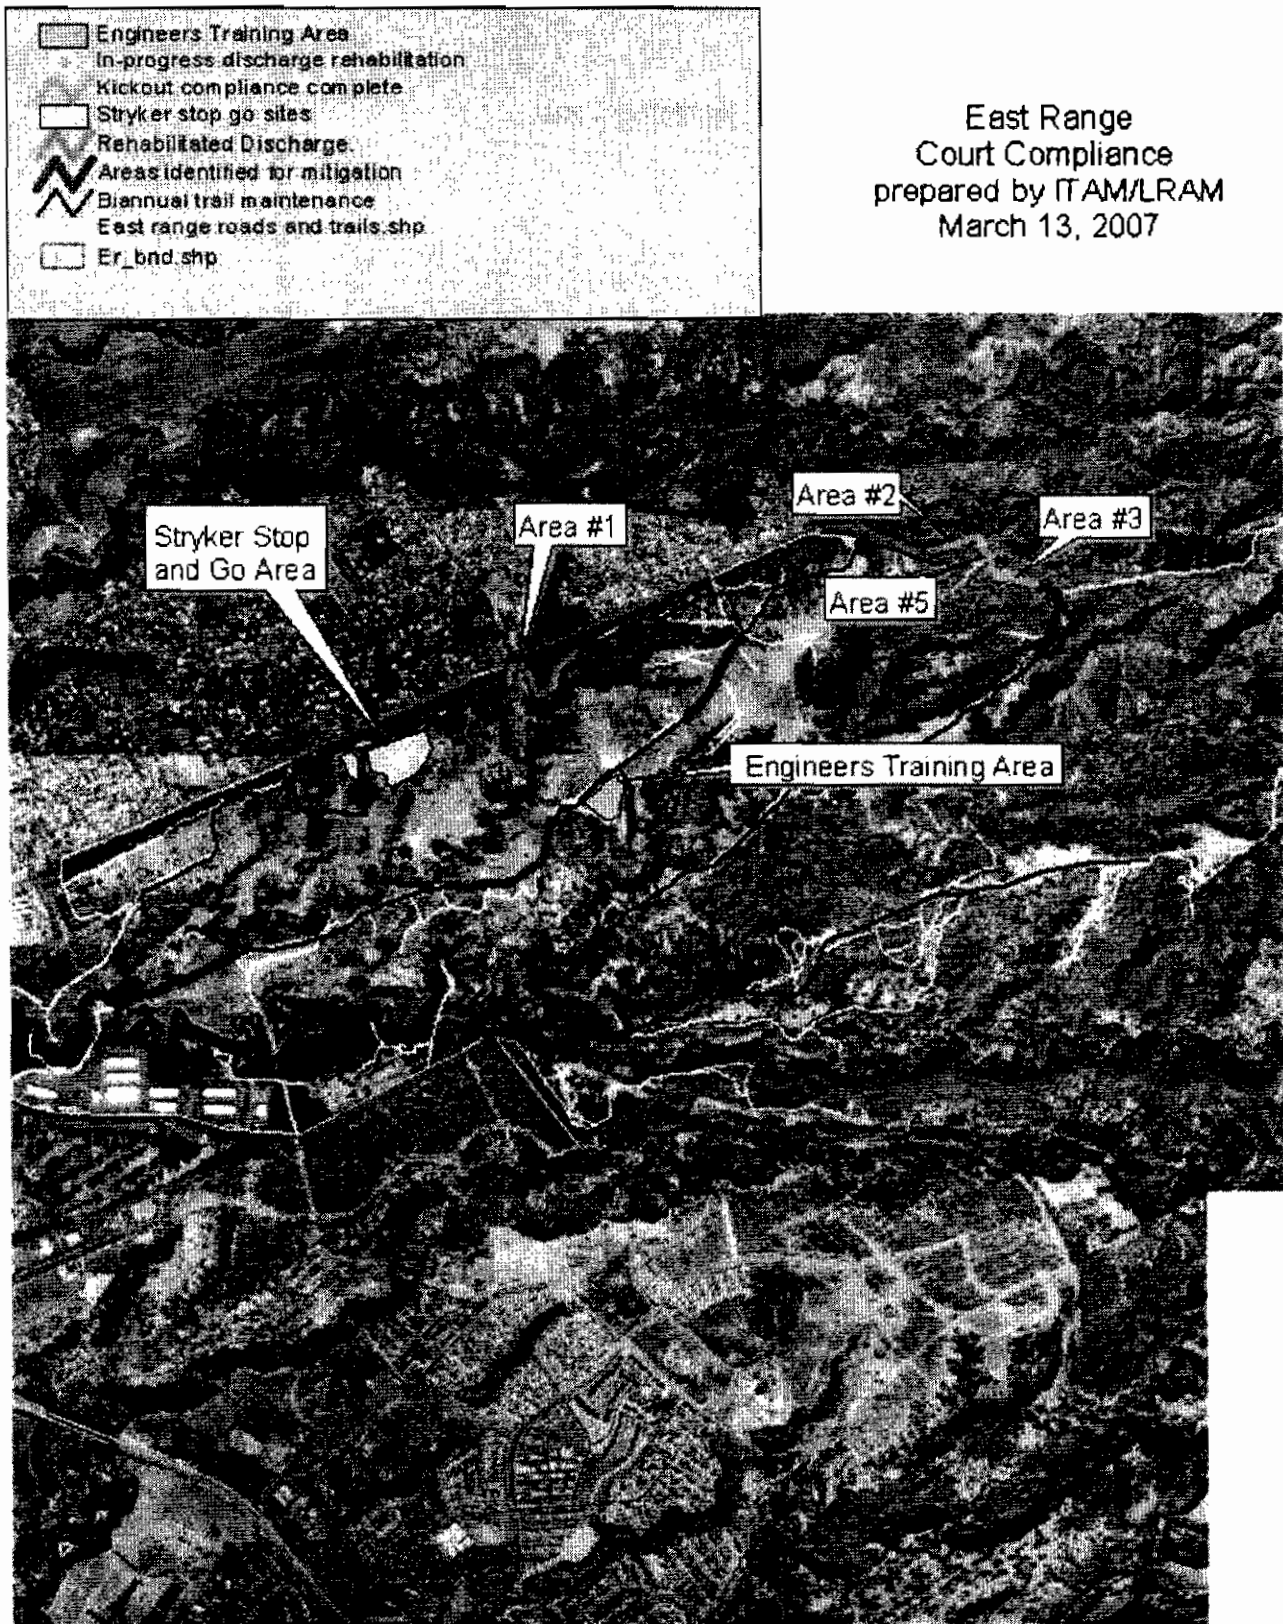
East Range Figure #1

- Area identified as #1 on the draft east range maintenance plan map.

The eastern stream approach (approximately 750 feet) has 4 Armored Broad Based Diversion Dips (BBDD) to move water flow from the upslope side of road to the down slope side of road. The exit or diversion component of the water flow control structure is armored with stone plus a slight, end of diversion upslope, to minimize any accelerated erosion and head cutting associated with the diversion. Exposed soil has been hydro mulched and seeded and or protected with erosion control blanket. The BBDD closest to the stream has a small level lip spreader which directs any waterflow away from the stream and into natural vegetation.

Up slope ditches connecting to each BBDD have been graded to a 4 foot width and 2 foot depth parabolic shape then armored with 6 inch surge rock for a depth of 12 inches. Due to soil type and typical soil water content the upper half of the east approach ditches has geo-grid as an underlayment in the armored ditch.

The upper section of the west approach (approximately 250 feet) has a compacted base course, geo-grid over base course, covered with a 12 inch stone layer. The stone layer runs from the upslope edge of road to the down slope side of the road. The road prism is an outsloped road. The stone layer is covered with 6 inches of 3 inch minus surface material.

The lower section of the west approach (approximately 85 feet) has an insloped road prism and a rock armored ditch which terminates into a settling basin.

- Area identified as #2 on the draft east range plan map.

A 200 foot section of the Red Course has been insloped to ensure water flow is directed away from the stream on the downslope side of the road. The insloped road prism is constructed using geo-grid and 12 inches of surge rock plus a surface layer of 3 inch minus. The associated diversion (kickout) is away from the stream and the diversion exit is armored with 6 inch stone.

- Area identified as #3 on the draft east range plan map.

This area, which is approximately 1200 feet in length, has been regraded, filled with 24 inches of crushed recycled concrete, geo-grid over the crushed concrete, 12 inches of surge rock plus 4 inches of 3 inch minus surface course over the geo-grid was added to create an insloped road section with a heavily armored inslope ditch line. A BBDD was added plus armored exit points. Upslope of the insloped road the road has an outsloped prism with an armored ditch and BBDDs. The ditch was graded to a 4 foot width and 2 foot depth parabolic shape then armored with 12 inches of surge rock. The road prism has geo-grid as an underlayment.

At the outlet of the settling basin, noted above in section 2.3.1 as Area #1 in east range, a 10 foot width by 20 foot stoned level lip spreader is installed. The level lip spreader stone thickness is 12 inches over geotextile cloth and geogrid.

The two discharge eroded gullies, associated with Area 1 on the east range, have been stabilized using geo-grid and rip-rap plus landscaping to divert any residual water flow along the longest possible path to the stream over a armored pathway. The uncontrolled

water flow which originally created the discharges has been controlled on both the east and west stream approaches as described above in Area 1 on East Range.

A discharge on the Red route identified as Area #5 on the attached East Range plan map was rehabilitated. The discharge was due to vehicle rutting of the unarmored ditches. The rehabilitation on Area #3 on the east range draft plan map plus an additional BBDD with an armored exit was installed. Hydromulch, erosion control blanket and seed will be applied to this area shortly.

The Engineer Training Area was identified, mapped, flagged and prepared for training activities with potentially high soil disturbance potential. The area has a 2 foot high berm on the down slope sides plus 2 outlet sections which have silt fence installed. This area is approximately 3 acres and is specifically controlled and monitored due to the high soil disturbance activities. This area is identified as "Engineer Training Area" area on the attached East Range plan map.

The Stryker stop/go area is surrounded down slope by roads with ditches and BBDDs. In addition there is natural vegetation between the training area and the road. The intact vegetative buffer is controlling soil movement from the stop and go training area. The stop and go area is scheduled to be hardened for continued use and if soil movement is noted, a berm around the stop and go area will be constructed. This area is identified as "Stryker Stop and Go" area on the attached East Range plan map.

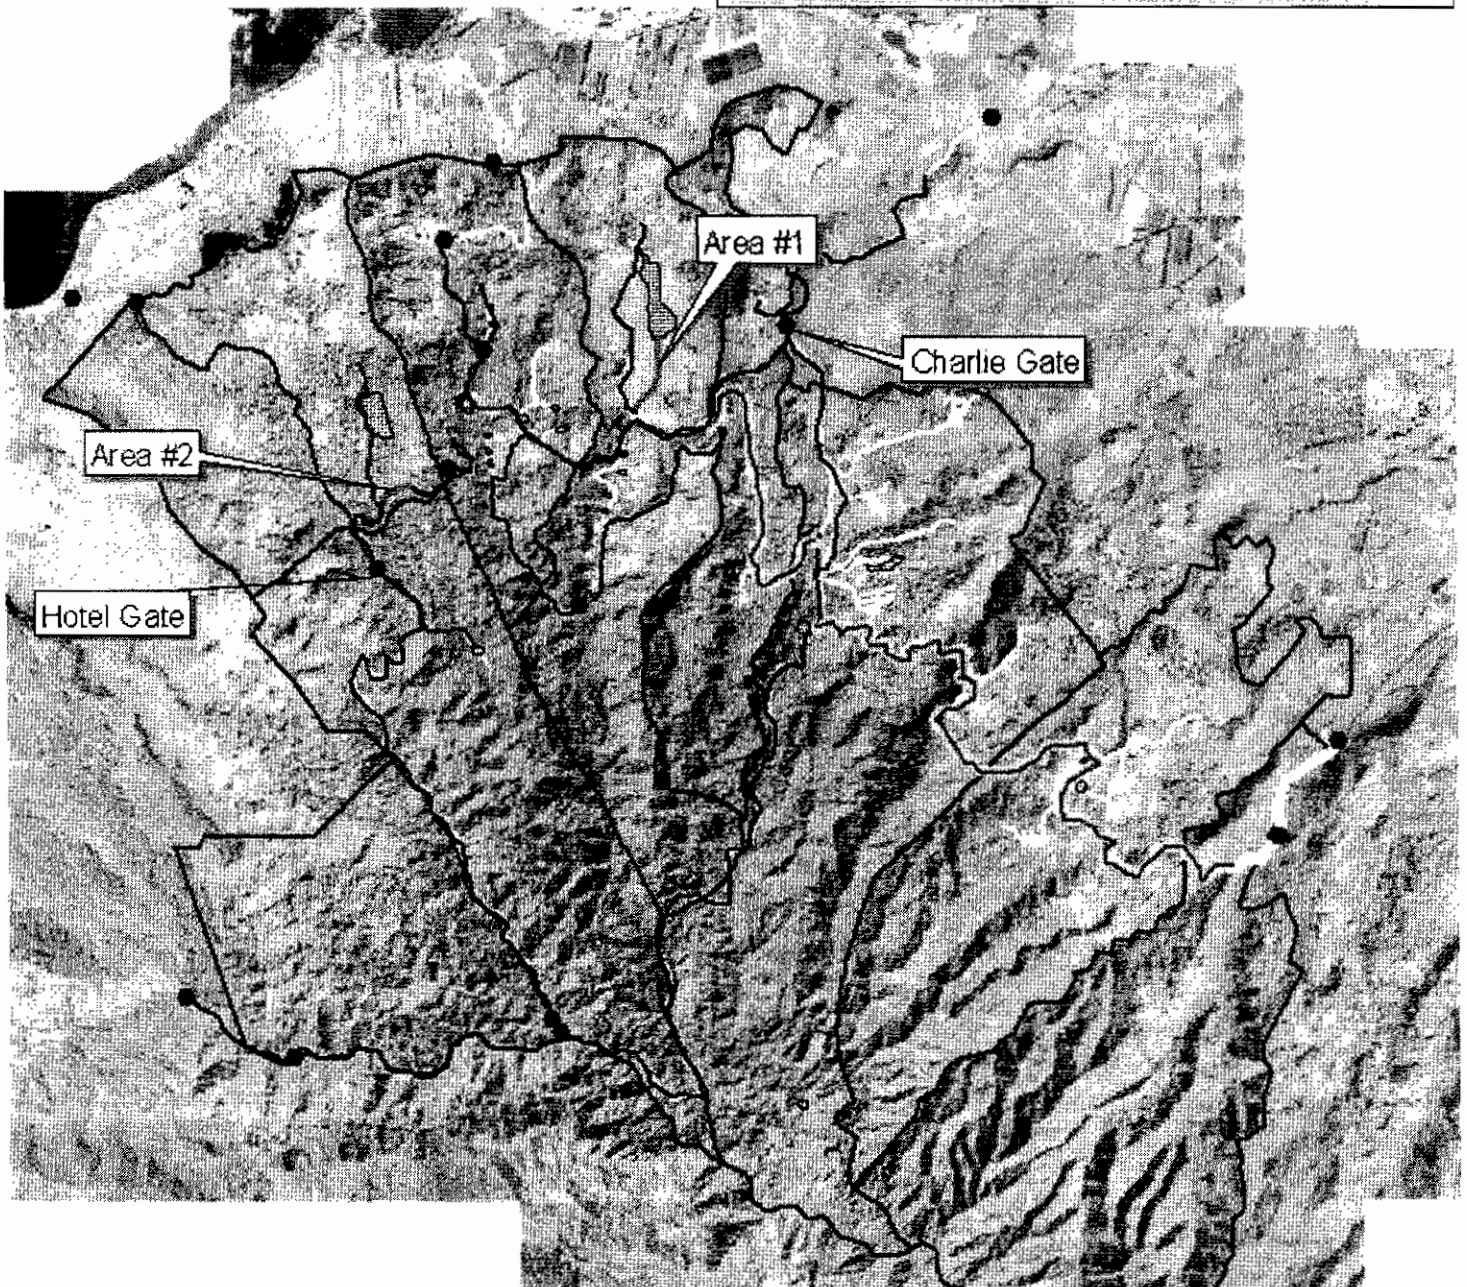
KTA Figure #2

- Area identified as #1 on the attached KTA range plan map.

Kane LZ access trail, which is approximately 1300 feet in length, has been reshaped creating a positive road prism with vegetative diversions, vegetated ditches and armored BBDD's with vegetated exit points. Reshaping the road prism allowed diversions (kickouts) to be constructed in addition to the ditches and BBDD's.

- Area identified as #2 on the attached KTA range map.

Xstrip MSR hill is a section of road where there are no possible opportunities for kickouts (diversions) along the 400 foot length of approximately 13% sloped road. Water flow at the top of the hill was diverted using a BBDD prior to any water flow creating volume or energy prior to running down the road segment. The road segment has an accentuated road crown with both ditches armored using 6 inch stone over geo-grid. The road segment also has an underlayment of geo-grid plus 12 inches of surge rock plus 6 inches of 3 inch minus surface material. The first opportunity was taken to create an armored BBDD at the bottom of the hill.

- Area identified from Charlie gate to Hotel gate on the attached KTA range plan map.

The road segment between Charlie gate and Hotel gate is in progress for road maintenance and compliance tasks. Initial activities have begun to address drainage issue. Additional measures will continue be implemented to ensure drainage structure stabilization is adequate for environmental protection and Stryker utilization.

Temporary physical marking (flagging, marking tape) of the allowable vehicle training areas (Go/No-go areas) has been completed. Off-road areas are being addressed on a priority basis based on anticipated level of training activity and current condition of the area. No rehabilitation is currently occurring at KTA due to the low volume of off-road vehicle traffic and the current well-planned and identified areas for Stryker off road activities. The current off-road areas are typically bowl shaped with a controlled exit point. The attached KTA range plan map shows areas identified for future rehabilitation and/or maintenance.
